PROJECT DESCRIPTION

The long, natural fjord that forms Northwest Arm is a unique part of the Halifax waterfront. A key element of the area's appeal are the walking paths and quarried stone seawalls along the shorelines of Horseshoe Island, Regatta Point and The Dingle. Damage to these seawalls from flooding and wave attack has created an ongoing maintenance issue. Because of our experience in incorporating future sea level rise in engineering assessments and designs, Coldwater was contracted by Halifax Regional Municipality (HRM) to develop a restoration strategy for the seawalls in light of recent storm events and future sea level rise, an appropriate design criteria for the Northwest Arm shoreline, and a conceptual seawall design.

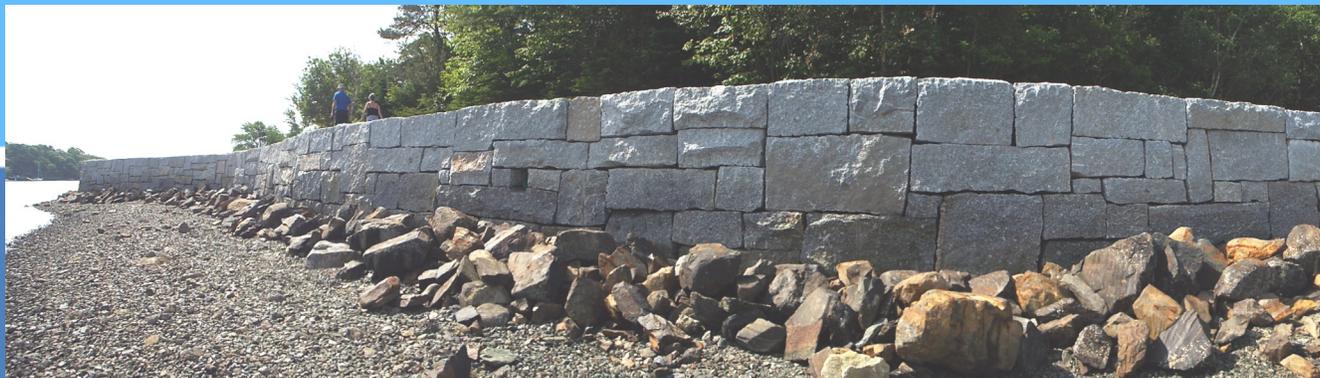
This process culminated in the design of a hewn granite block wall to replace the ageing seawall at Sir Sandford Fleming Park (known locally as The Dingle). The 3rd phase of construction is now underway. Stonework and quarrying is being undertaken by Lange's rock farm www.langesrockfarm.com.
